# Misunderstanding the Roman Wall at Tower Hill

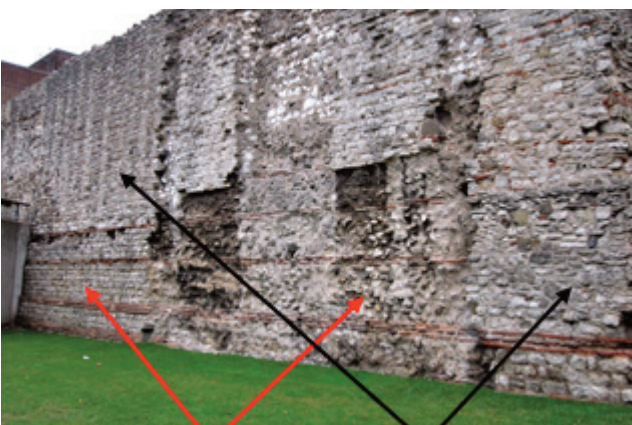
This section can be divided into two – that to the right is the core of the wall, with the facing stones robbed at some point in the past (top). The section to the left shows the original facing stones still *in situ*. This shows how the Wall would have been seen in the Roman period (except there was probably an earth bank covering this interior face). The tile courses go through the entire width of the Roman Wall, and are thought to stabilise and level the rubble core of the wall, and, perhaps to add a decorative element (centre).

Further to the right, the stonework is much less regular, has no tile courses and is made up of re-used Roman building material, tiles and ragstone, and not laid in neat courses. It clearly post-dates the Roman period, and was probably either late Saxon or medieval. This area is similar to the upper face of the wall (on the left) and, as can be seen, the horizontal Roman tile courses do not continue through either, except for the very lowest visible tile course to the right. Close inspection shows that this anomaly must have been caused by a collapse of the inner face of the Wall and must have been rebuilt at some point without the tile courses. The lowest Roman tile course clearly survived the wall collapse.

**TOP:** Roman Wall and core (arrowed in red) with the later repair without tile courses (in black)

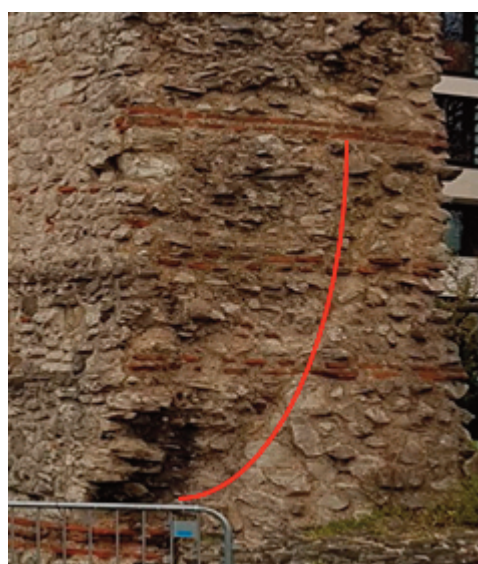
In the 1980s, someone with a bucket of cement and some Roman tile fragments, added spurious tile courses to a non-Roman wall (bottom). I presume it was done by English Heritage who wanted to make the exposed wall section look properly and completely Roman, and did not notice the clear evidence of the wall collapse as an explanation for the fact that the tile courses did not go right through the width of the wall.

**BOTTOM:** Close-up of section through the Wall showing the real Roman tile courses to the right

This is a minor issue, but it is an error, and it distorts a genuine area of post-Roman Wall and turns it into a pretend piece of Roman Wall. The mistake is also present in the ceramic panel for the London Wall Walk. Both should be put right.
